Suite 1501, Northbrook Office Court
666 West Dundee Road, Northbrook, IL 60062 • (312) 498-9094TECHNICAL ASSISTANCE TEAM FOR EMERGENCY RESPONSE REMOVAL AND PREVENTION
EPA CONTRACT 68-01-6669Mr. Robert Bowden, Chief
Spill Response Section
Environmental Protection Agency
536 South Clark Street
Chicago, IL 60604

20 October 1983

TAT-5-8310-05

On 14 and 17 October 1983, officers from the Illinois Department of Law Enforcement, Division of State Police, and TAT member Stofferahn conducted inspections of six sites in the Chicago area being used to store cyanide contaminated film chips. These visits were made to assess the structural integrity of the semi-trailer vans which are holding the waste.

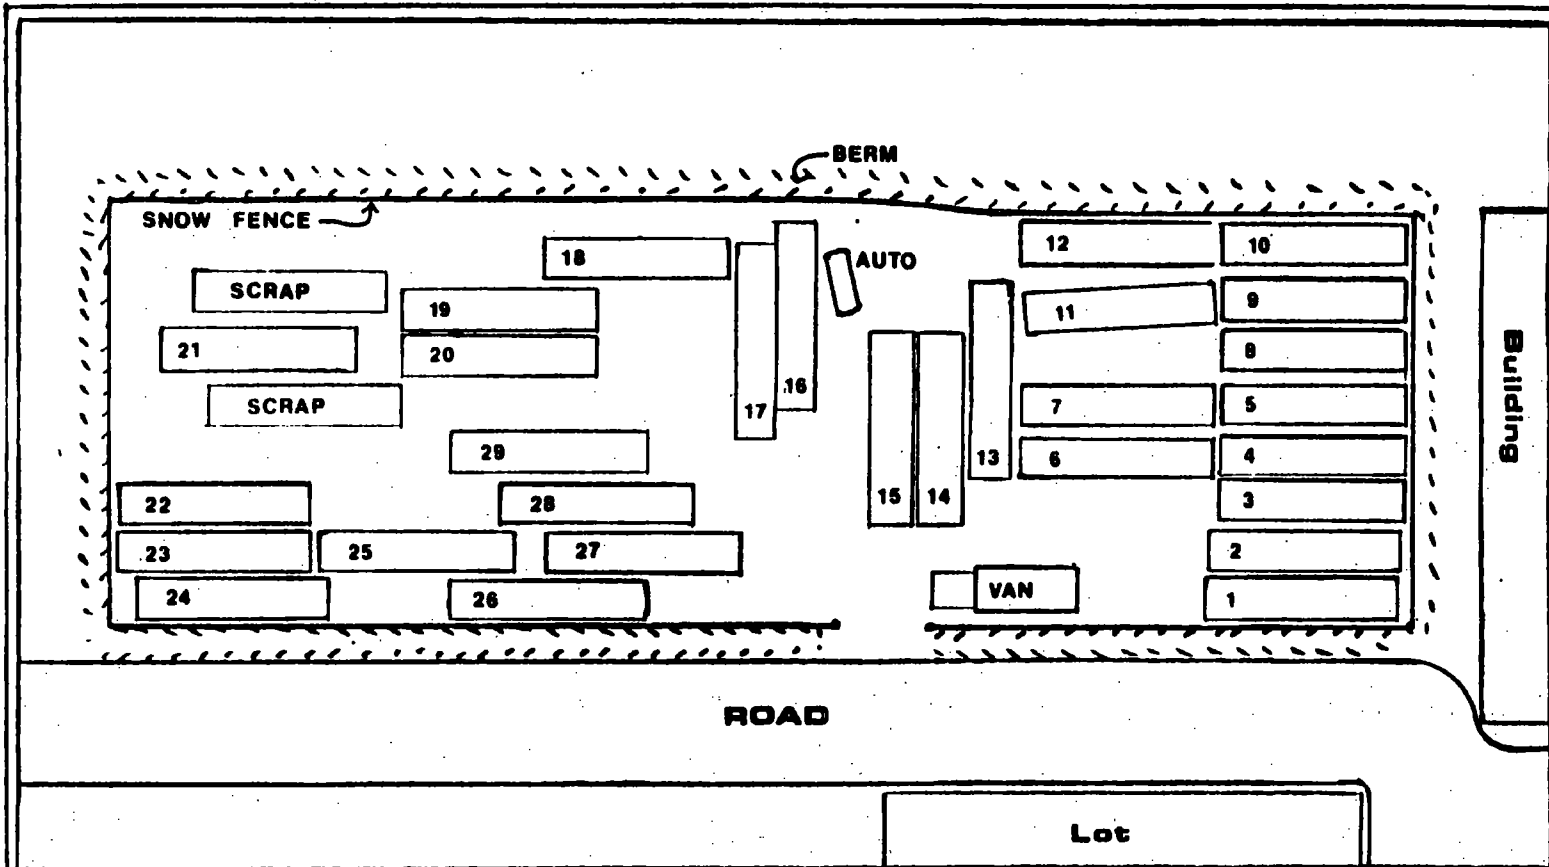
Figure 1

On 14 October 1983, TAT member Stofferahn met with Troopers Koch and DeLacy at District Three Headquarters of the Illinois State Police, 4051 N. Harlem Avenue, Chicago. After a brief explanation as to what the site assessments were to involve, the troopers and TAT proceeded to the Red Devil Manufacturing facility at 5995 North River Road, Rosemont, Illinois (Figure 1). Twenty-nine trailers were numbered with spray paint and categorized. The results of the assessment are given in Table 1. Trailer three was found to contain no waste chips. All other trailers were noted to be leaking or seeping leachate to some extent. Five trailers, numbers 13, 15, 18, 27 and 28, were recommended by the officers to be offloaded. The trailers are confined to a small bermed area, and little room to access the majority of the trailers exists. A small asphalt lot was noted across the street from the site which could potentially be used to temporarily store the structurally sound units while the others are being repaired or off-loaded. No information as to the owner of this lot was available at this time.

<u>Trailer #</u>	<u>Category</u>	<u>Comments</u>
1	B	Clear side door and seal
2	C	Patch front seam
3		No waste found inside
4	B	Locked
5	B	Clear rear door
6	C	Front seams corrosion
7	C	Repair back door
8	C	Clear doors and seal
9	C	Seam corrosion
10	B	Locked
11	C	Repair rear door
12	C	Repair rear door
13	D	Waste leakage through floor hole
14	C	Front seam corrosion
15	D	Front and sides leaking chips
16	C	Repair back door, side seams corrosion
17	B	Clear door of chips
18	D	Sides of leaking chips
19	C	Replace back door
20	C	Reinforce floor, front seam corrosion
21	B	Corroded seams
22	C	Seam corrosion, reinforce door
23	B	Clear door seams of chips
24	B	Clear door seams of chips
25	C	Reinforce floor, front side seam corrosion
26	C	Repair rear door
27	D	Chip leakage at doors
28	D	Chip leakage at doors
29	C	Reinforce floor, clear doors

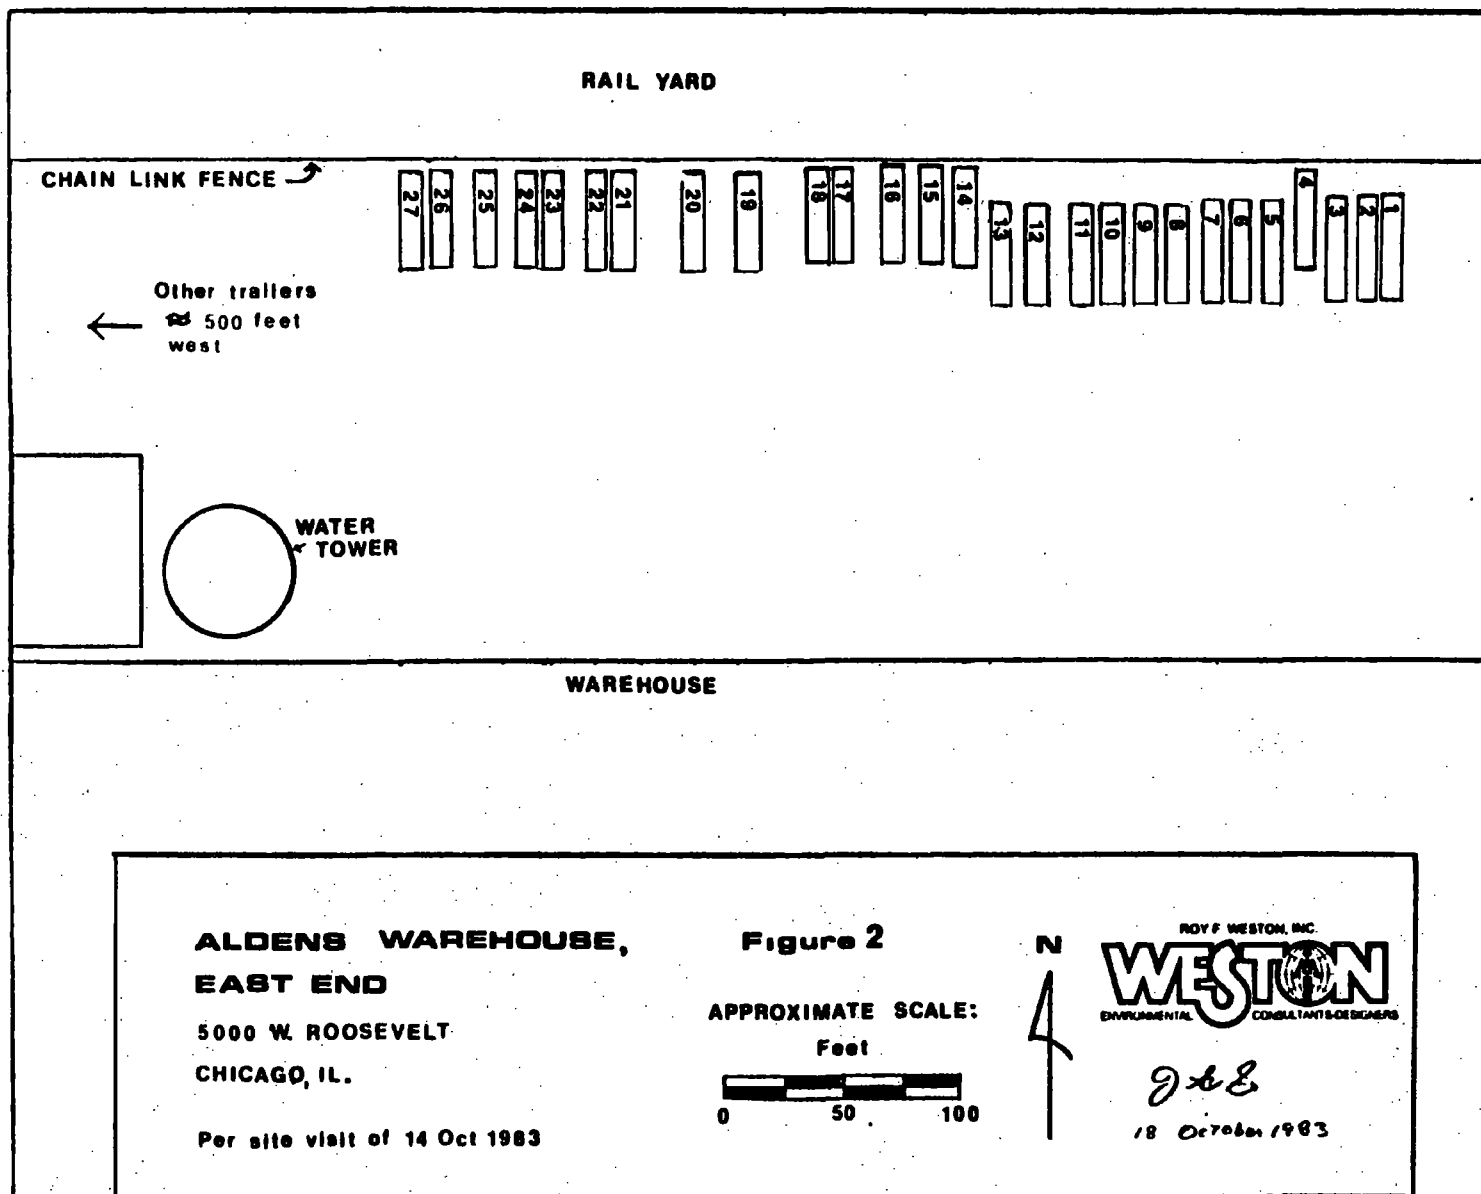
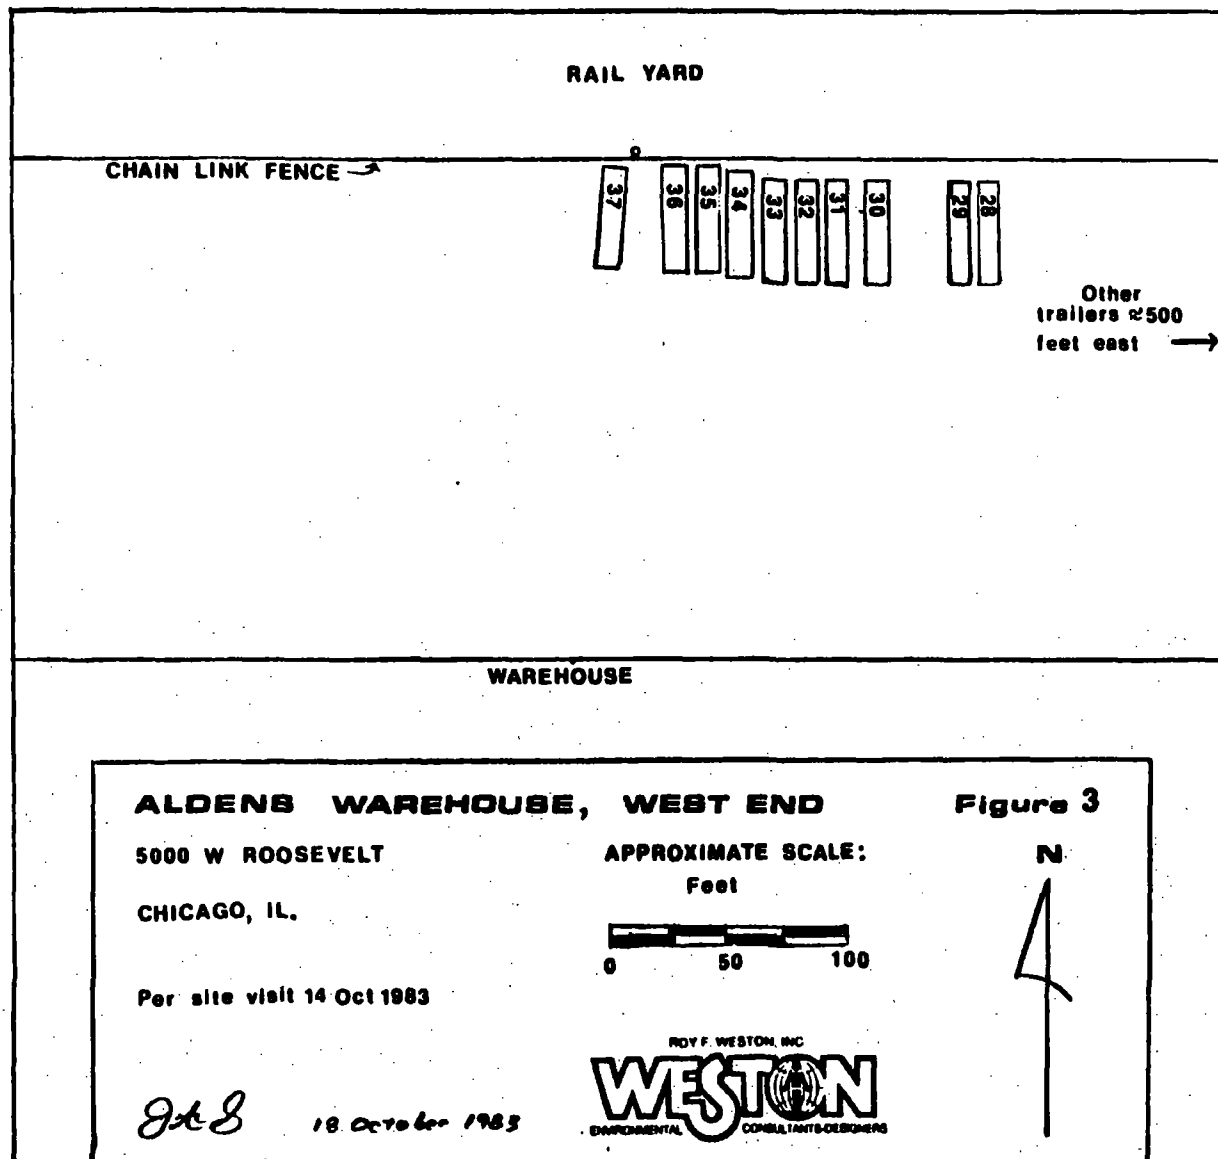
From the Rosemont site, the troopers and TAT proceeded to the abandoned Aldens warehouse site at 5000 W. Roosevelt, Chicago (Figures 2 and 3). Thirty-seven trailers containing chips were numbered with indelible markers. Twenty-seven of these trailers contain chips which were treated with sodium hypochlorite solution by Petrochem Services, Inc., during a state-funded Emergency Action this last summer. Recent analyses, however, have shown these chips still contain significant levels of cyanide and were included in the assessment. The results of the assessment are given in Table 2. Again, all the trailers showed signs of leakage or seepage of leachate (as the weather has been relatively dry prior to the site visits, most of the trailers at this and the Rosemont site were not actively leaking, but showed definite signs of past leakage). The troopers recommended that ten trailers, numbers 2, 3, 5, 11, 17, 30, 32, 33, 34 and 35, should be off-loaded. The trailers are situated on a

<u>Trailer #</u>	<u>Category</u>	<u>Comments</u>
1	C	Repair floor
2	D	Chips leak at seams, sides bulging
3	D	Front bulging, seams leaking
4	B	Corrosion at door and seams
5	D	Floor and back door unstable, leaking chips
6	C	Repair floor
7	C	Repair floor
8	B	Clear back door
9	C	Front seam corrosion, reinforce back door
10	C	Seam corrosion, seal back door
11	D	Sides bulged, chips leaking at rear
12	C	Seam corrosion, clear rear door
13	B	Clear rear door
14	C	Repair rear door
15	C	Seam corrosion, replace rear door
16	C	Clear rear door, front seam corrosion
17	D	Hole in floor, sides corroded
18	C	Front seam corrosion seal rear
19	C	Seam corrosion
20	C	Seam corrosion
21	C	Seam corrosion
22	C	Seam corrosion
23	C	Seam corrosion
24	C	Seam corrosion
25	C	Seam corrosion
26	C	Seam corrosion
27	C	Seam corrosion
28	C	Seam corrosion
29	C	Seam corrosion
30	D	Sides bulging
31	C	Seam corrosion
32	D	Unstable sides and rear
33	D	Leakage of chips through side corrosion

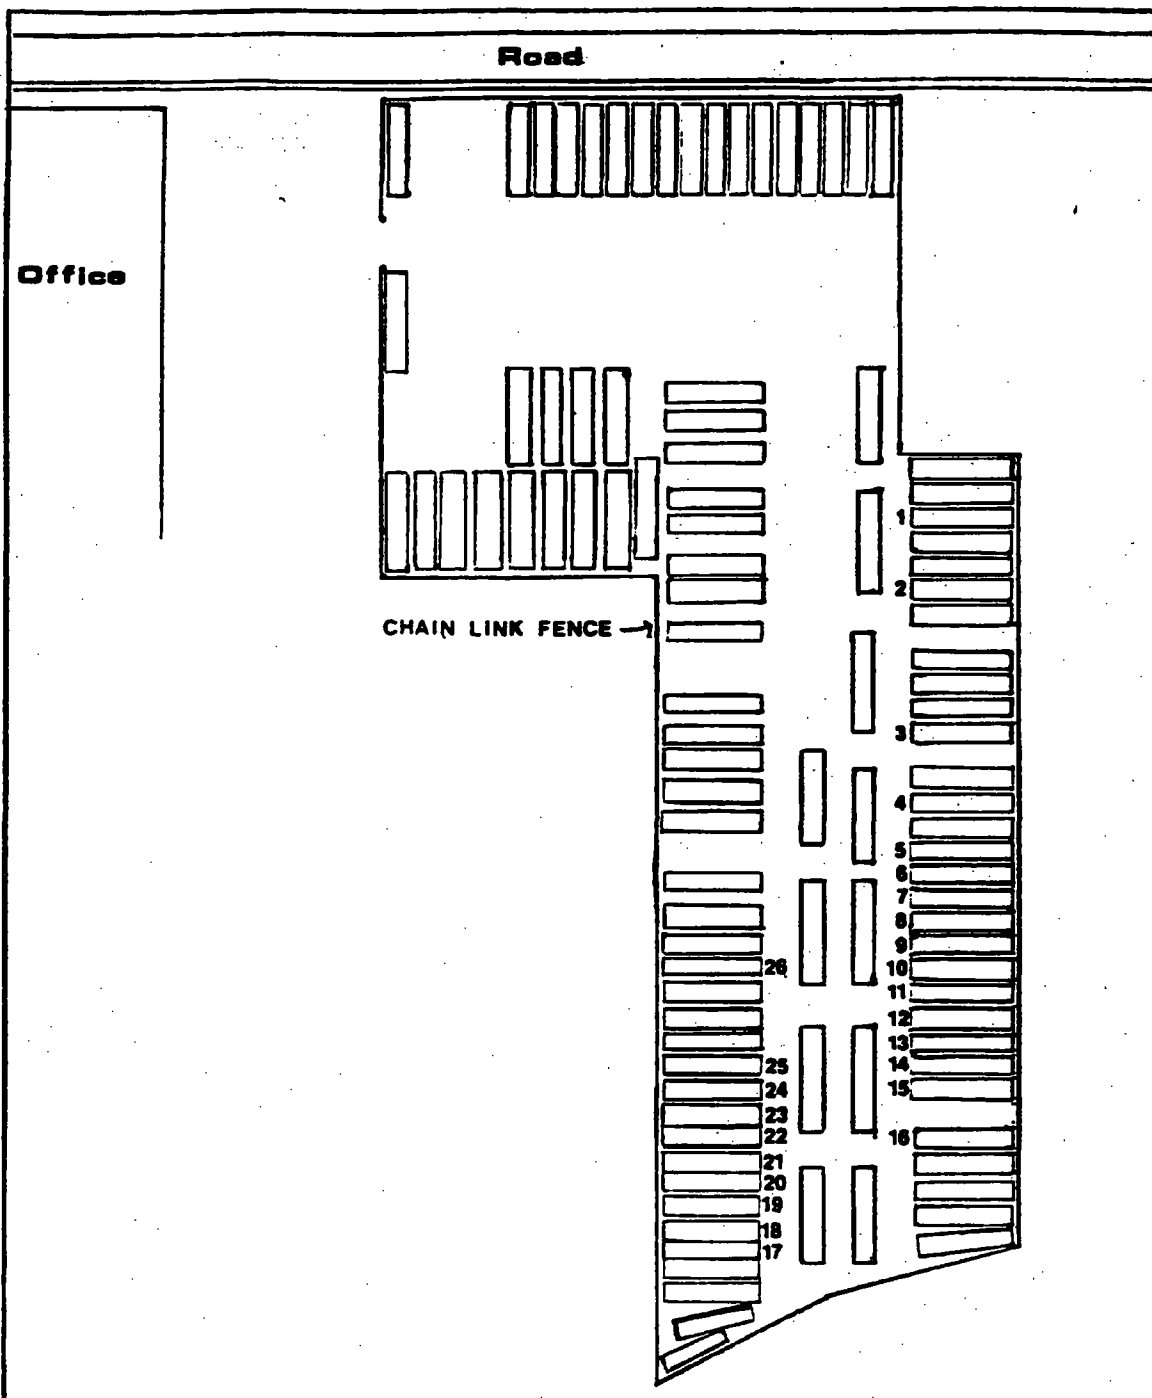
GEMINI LEASING (RITE-WAY) Figure 4

On 17 October 1983, TAT member Stofferahn met with Sargent Underwood and Troopers Zipsie and Patterson from District Four State Police Headquarters (13863 S. Cicero, Crestwood, Illinois) at the Gemini Leasing yard, 6021 S. East Avenue, Hodgkins, Illinois (Figure 4). The Gemini Leasing yard is an active facility. Twenty-six trailers containing waste chips located here were numbered with indelible markers. The results of the assessment of these trailers are given in Table 3. Most of the trailers were leaking; some were without jack stands. Nine trailers, numbers 11, 12, 14, 17, 19, 22, 23, 25 and 26, were recommended for offloading by the troopers. While gaining access to the twenty-six trailers will require only a minimal amount of movement of other units on the yard, acquiring room for repairs and offloading will be a problem due to the fact that this is an active place of business. The owner of the yard, who TAT met briefly during the site visit, complained that the waste trailers were taking up space on his yard which he could be utilizing for paying customers. The addition of ten more trailers, or several roll-off boxes, to store the chips from the ten unsound units is not anticipated to elicit a favorable response from Gemini officials.

<u>Trailer #</u>	<u>Category</u>	<u>Comments</u>
1	B	Leaking at front
2	B	Leaking at front
3	B	Leaking at front
4	C	Repair side door, sides bowed
5	C	Side door sprung, leaking
6	B	Leaking - floor rotting
7	A	
8	C	Floor rotting, sides sprung from frame
9	C	Side walls sprung, seam corrosion
10	C	Seam corrosion
11	D	Holes in side, floor rotting
12	D	Holes in side, floor near collapse
13	C	Side seam corrosion, floor leakage
14	D	Side corrosion, floor leakage
15	C	Side walls sprung, leaking
16	C	Side corrosion, leaking
17	D	Side corrosion, leaking
18	C	Front seam corrosion, leaking
19	D	Side corrosion, leaking
20	B	
21	C	Minimal side corrosion, leaking
22	D	Top damaged, side walls sprung, leaking
23	D	Side walls sprung, front and side seam corrosion
24	C	Front seam corrosion, leaking
25	D	Floor buckled, sides bowed, leaking
26	D	Side corrosion, leaking

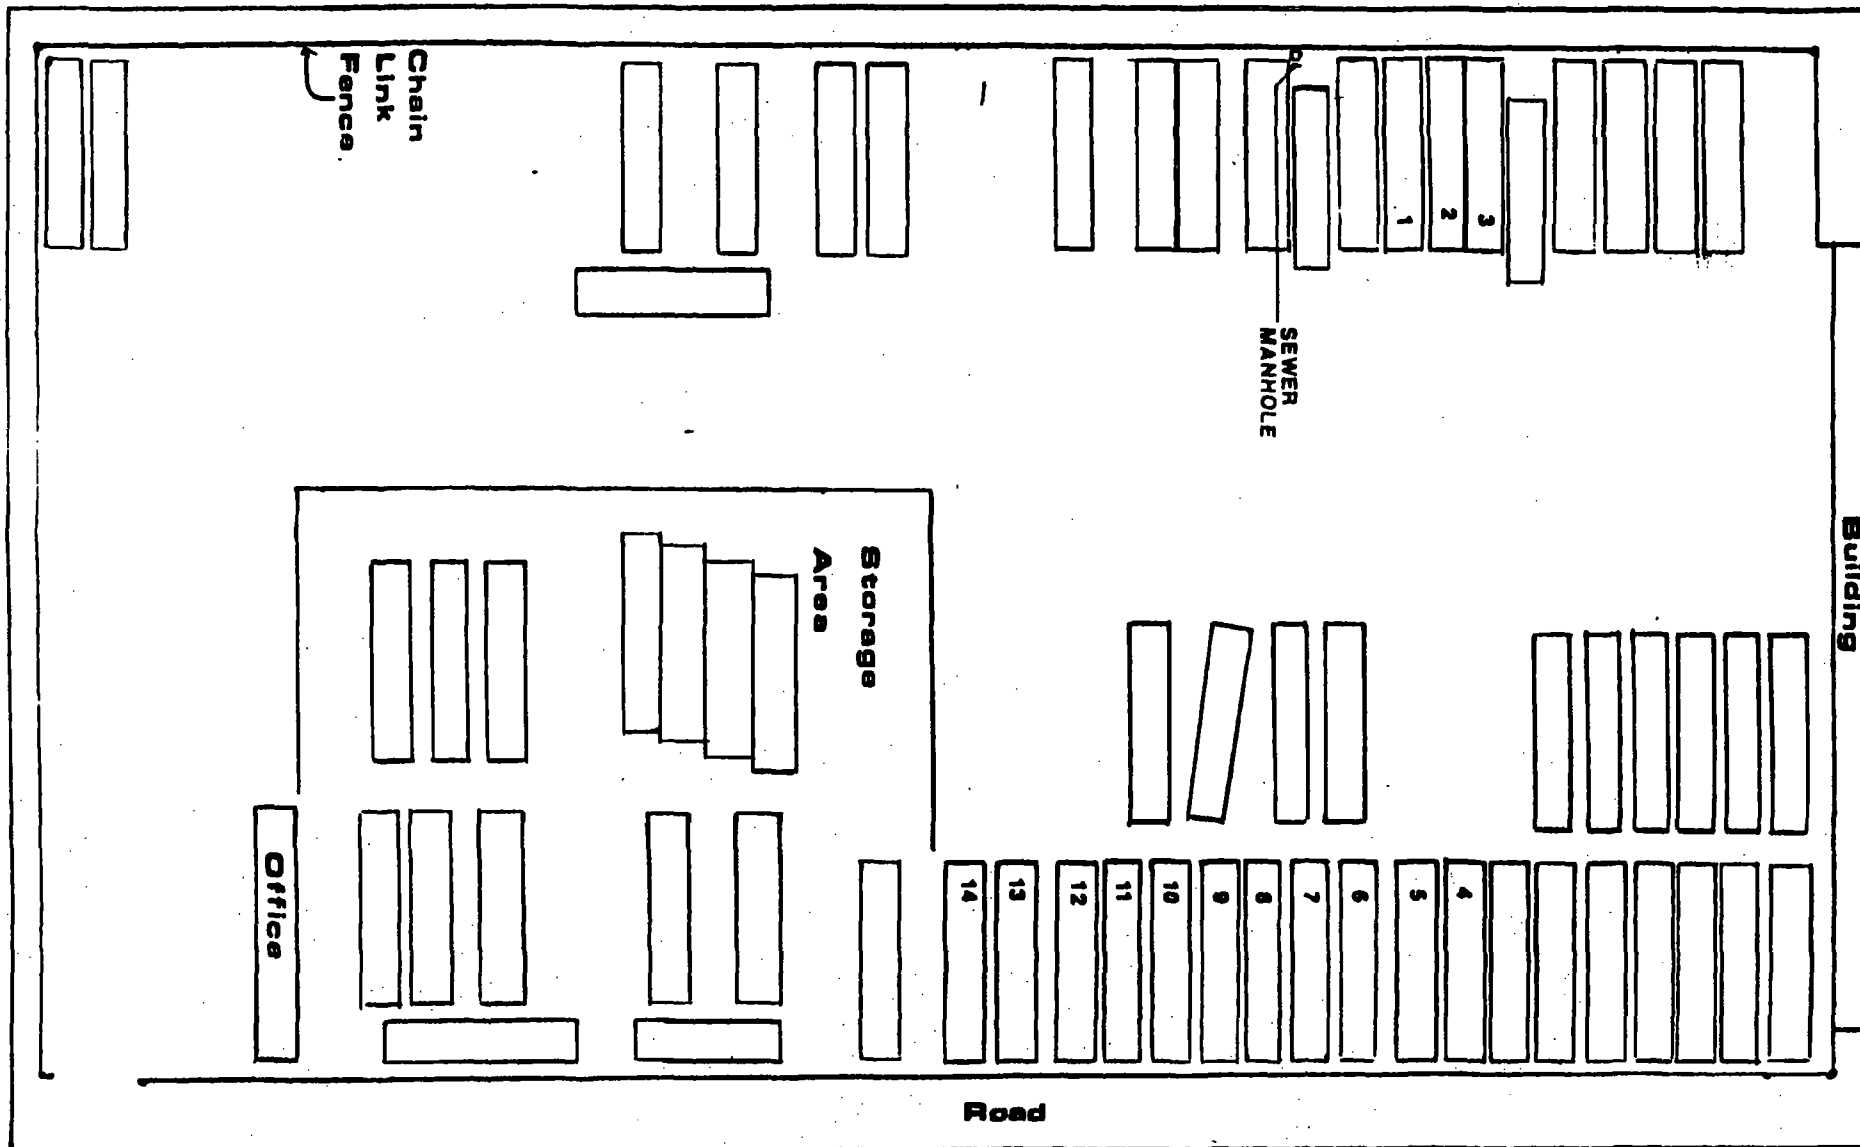
Figure 5

The next site assessed was J's Mobile Semi-Trailer Repair yard at 8765 W. Joliet Road, McCook, Illinois (Figure 5). Fourteen trailers located here were numbered and assessed. The results of the assessment are given in Table 4. Leakage of leachate from these trailers had been found to be migrating off site via a storm sewer by personnel from the Metropolitan Sanitary District of Greater Chicago (MSD) in September of 1983. Four trailers, numbers 1, 3, 6 and 7, were recommended to be offloaded. As with the Gemini Leasing yard, this is an active trailer yard. Access to the waste trailers is not anticipated to be a serious problem; however, finding enough room for repairs and offloading is.

<u>Trailer #</u>	<u>Category</u>	<u>Comments</u>
1	D	Rear door missing, side and front corrosion
2	C	Possible frame damage, side corrosion
3	D	Floor in very bad condition
4	B	Floor leakage
5	C	Rear seam corrosion
6	D	Much floor rotting
7	D	Floor buckled, considerable seam corrosion
8	C	Right side corrosion, clear rear door
9	C	Front and left side corrosion
10	C	Cross member in floor bowed and twisted, side corrosion
11	B	Leaking at rear door
12	C	Side corrosion
13	C	Side corrosion
14	A

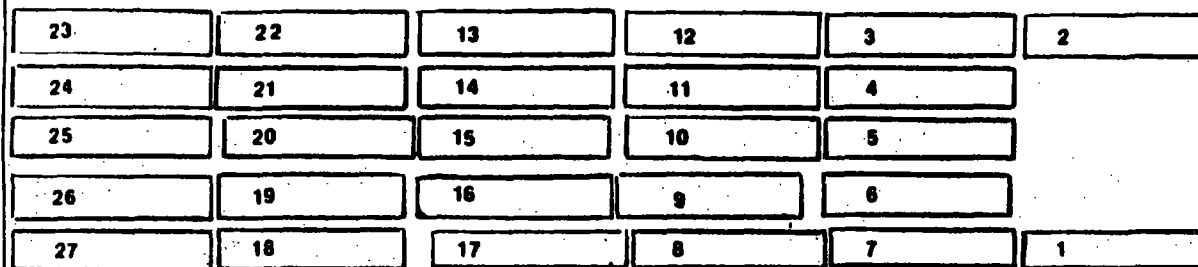
EAGLE TRAILER INC. Figure 6

The Eagles Trailer yard at 7710 W. 57th Street, Summit, Illinois (Figure 6), was the next site visited. Twenty-seven trailers containing waste were numbered and assessed. The results of the assessment are given in Table 5. As with the J's site, off-site migration of cyanide via a drainage ditch along the southern parameter of the site was documented by the MSD last September. Three units, numbers 2, 4 and 16, were recommended for off-loading. A considerable access and congestion problem was noted at this site. There is a totally inadequate amount of space within the area where the trailers are parked for any amount of work to be done. The trailer repair yard to the north is active, and cannot be used. The paved area leading to Archer Avenue could be used for temporary storage of sound units. To the northeast, TAT noticed a very large paved parking lot and what appeared to be abandoned buildings. This lot could also potentially be utilized for temporary storage or working space. An Eagle's employee stated this facility was owned by Ryder P.I.E., and supplied TAT with a business card for a contact with the firm (Attachment 1).

<u>Trailer #</u>	<u>Category</u>	<u>Comments</u>
1	B	
2	D	Side corrosion
3	B	
4	D	Side corrosion
5	B	
6	B	
7	B	
8	C	Side corrosion
9	B	Leaking side door
10	B	Leaking side door
11	B	Leaking floor
12	B	Leaking side door
13	B	Leaking floor
14	B	Leaking sides
15	B	
16	D	Side seam corrosion, side door sprung
17	B	Leaking sides
18	B	Leaking front
19	C	Front upright brace cracked, front seam corrosion
20	B	Leaking side
21	A	
22	B	Leaking floor
23	B	
24	A	
25	A	
26	B	Leaking side
27	B	Leaking floor

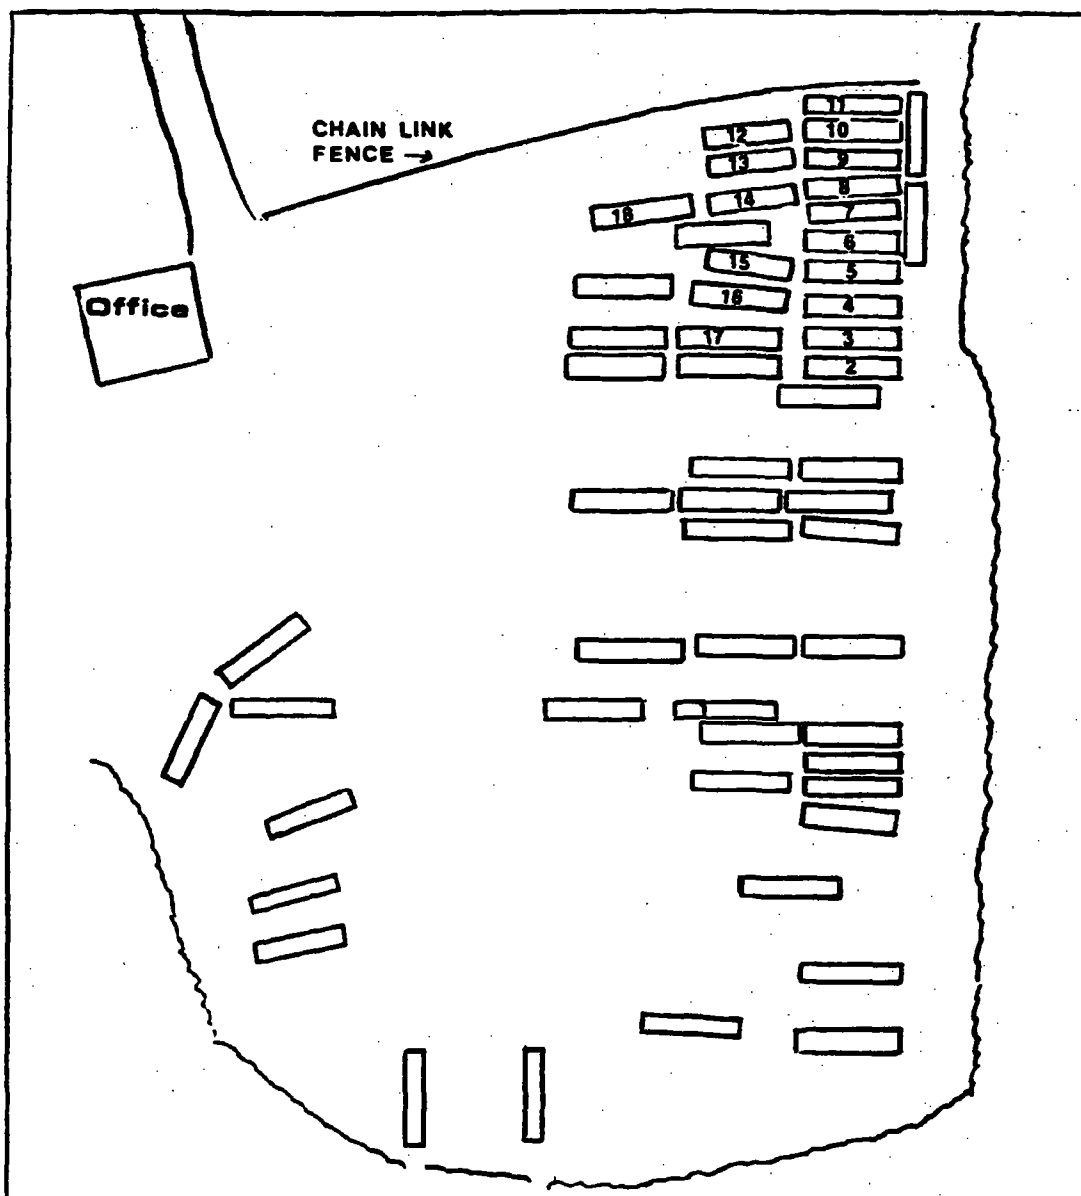
Figure 7

The Livco trailer yard at 6700 W. 130rd Street, Chicago Ridge, Illinois, (Figure 7), was the last site visited. Eighteen trailers containing waste were numbered and inspected at this facility. Table 6 provides the results of this assessment. All the units were leaking or seeping leachate, but only one, number 55, was recommended for offloading. While this is also an active facility, no significant access or congestion problems are anticipated.

<u>Trailer #</u>	<u>Category</u>	<u>Comments</u>
1	B	
2	B	Leaking floor
3	B	Leaking floor
4	B	Leaking floor, front seam
5	D	Side seam corrosion, possible collapse
6	B	Front seam corrosion
7	B	Leaking floor
8	B	Leaking floor
9	B	Leaking floor
10	B	Leaking floor
11	B	Leaking floor
12	B	Front seam corrosion
13	B	Leaking floor
14	B	Leaking floor
15	C	Front seam corrosion, possible collapse
16	B	Leaking floor
17	B	Leaking floor, front seam corrosion
18	B	Leaking floor, side seam corrosion
